Disassembly and Visual Inspection of CANDU Modified 37-element Bundle

S.K. Woo^{1*}, M.J. Kim¹, H.S. Kim²

¹KEPCO Nuclear Fuel, 493 Duckjin-Dong, Yuseong-Ku, Daejeon 305-353, skwoo@knfc.co.kr

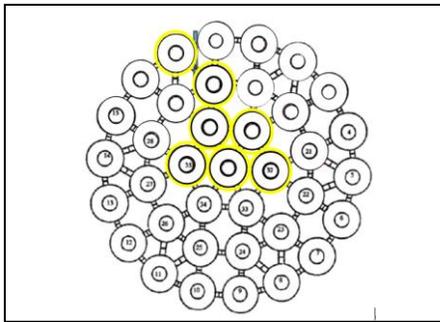
Fig. 4. Map of Desired Elements for Visual Inspection

The number of desired elements for the visual inspection is seven among nineteen separated elements (Fig. 4). The inspection items are physical deformation, surface discoloration, signs of fission gas leak, wear, physical damage of the end plug, weld defect and signs of wear or corrosion.

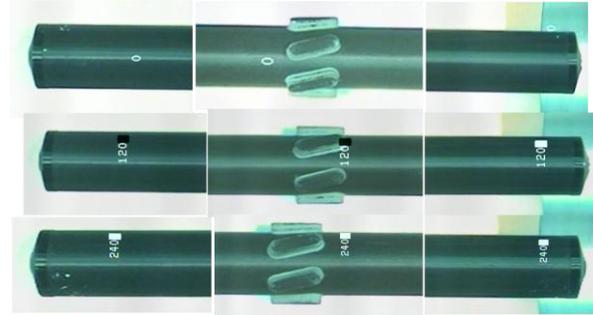
Fig. 5. Visual Inspection using Three Rotation Angles

Visual Inspection on fuel elements is conducted with rotating the desired elements for three angles (120°, 240°, 360°) (Fig. 5). The inspection is recorded, and any unusual features on the elements are noted.
